INSTALLING PACKERS ON A CHASSIS WITH FLANGE RIVETS

The following document has been prepared by TCS to provide guidance to vehicle modifiers when installing a body onto a vehicle that has rivets and/or bolts protruding above the upper surface of the top chassis rail flanges.

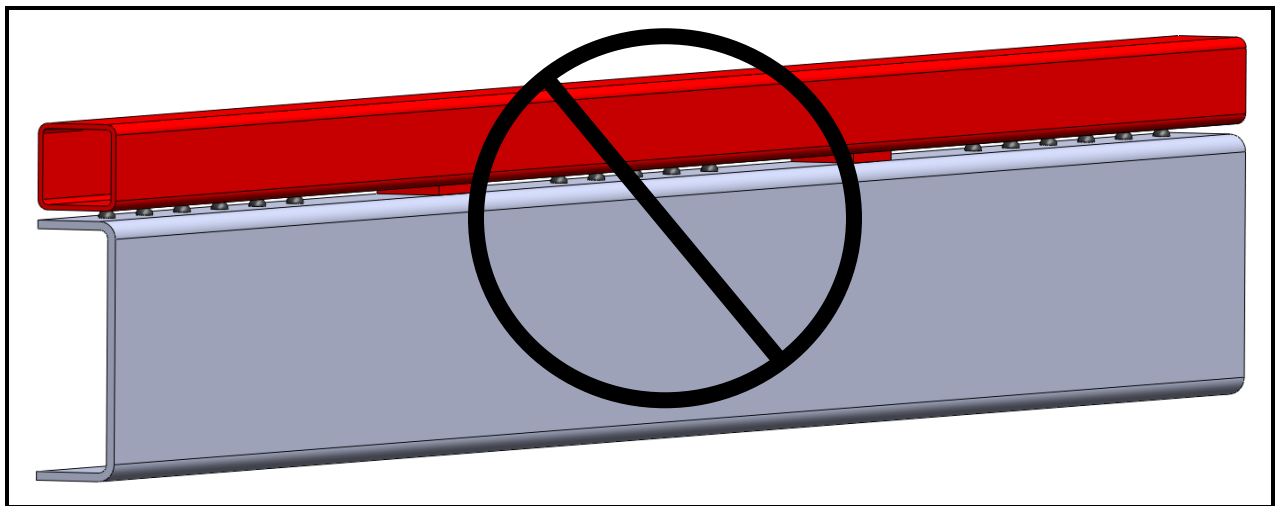
Packers are often installed in the manner shown in Figure 1 below. Installing these small packers subjects the upper chassis rail flange to localised stresses and can lead to deformation of the flange. The engineers at TCS have witnessed the after-effects of such deformation and subsequent chassis failure and for this reason TCS **will not** issue a VASS certificate for vehicles that have packers installed in this manner. TCS **will only** issue a VASS certificate if the packers extend along the full length of the sub-frame, (if this is not practicable, TCS should be consulted prior to commencing the modification).

Figure 1: Unacceptable Packer Installation between Chassis and Sub-Frame

Ideally, full length packers should be installed prior to installing the subframe and body. One method of achieving this is to measure the locations of the rivets then cut holes in the packers so they can sit flush on the upper surface of the top chassis rail flange. This method prevents the packers from falling out as they are held in place by the rivets. Once the packers have been installed, the subframe can rest on the packers and the body can be installed in accordance with Section J of VSB-6.

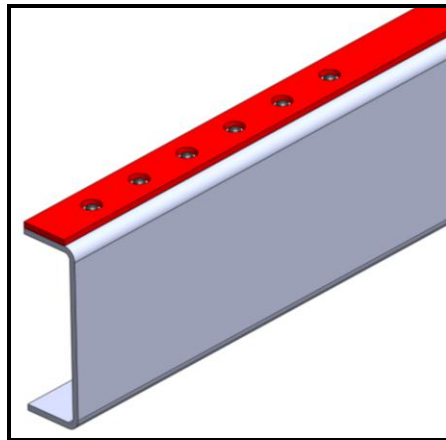
Figure 2: Preferred Packer Configuration (Sub-Frame not shown)

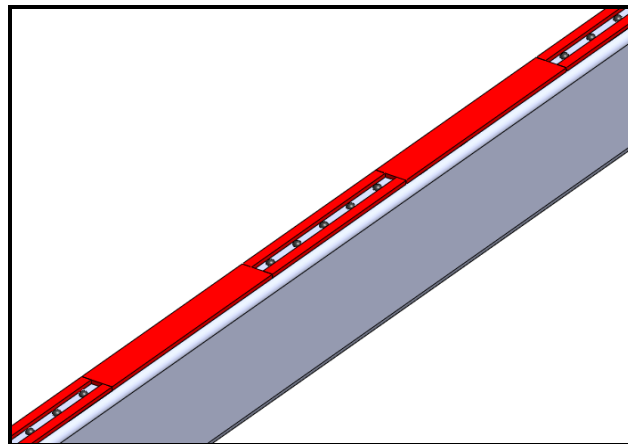
If the body has already been installed and the packers are not satisfactory, the problem can be rectified by installing full width packers in the regions where rivets/bolts are not present and installing narrower packers either side of the rivets, as shown in Figure 3 below:

Figure 3: Possible Packer Configuration for pre-existing bodies (Sub-Frame not shown)

If this method is used, the packers must be adequately secured so that they do not fall out. If metal packers are used, it may be acceptable to weld them to the sub-frame in a manner which doesn't affect the structural integrity of the chassis. Care should be taken to ensure the chassis is not subjected to high temperatures. Packers and/or any other brackets/equipment must never be welded to the chassis.

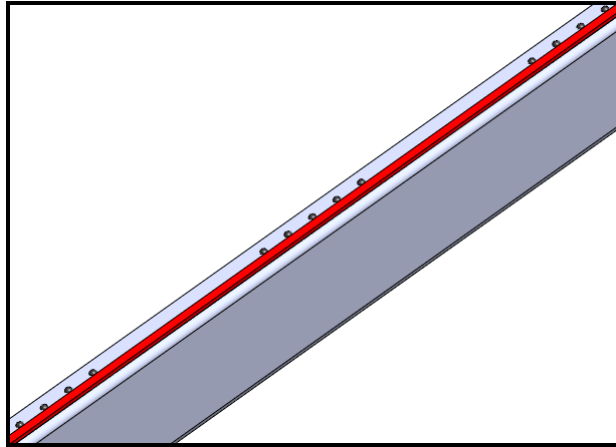
Figure 4: Alternative Packer Configuration to Figure 2

As long as the contact surface between the chassis and the packer is consistent along the length of the packer, this configuration is also acceptable.

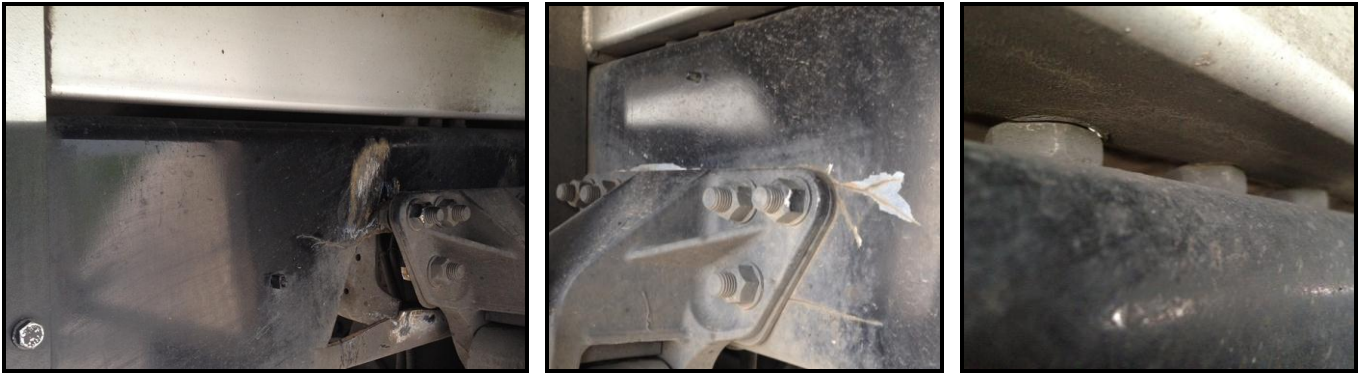
Figures 5a, 5b and 5c: Alternative Packer Configuration to Figure 2

TCS is often engaged to provide repair advice when a structural failure has occurred on a vehicle. The photos below show the potential consequences for not following these guidelines.

It is evident from the figures 5a to 5c that excessive vertical chassis vibration has occurred in the region where continuous packers are not present, which contributed to the cracks around the suspension hanger bolts. Inserting a continuous packer between the chassis and the sub-frame would have greatly reduced this chassis vibration.
