INSTALLING PACKERS ON A CHASSIS WITH FLANGE RIVETS

The following document has been prepared by TCS to provide guidance to vehicle modifiers when installing a body onto a vehicle that has rivets and/or bolts protruding above the upper surface of the top chassis rail flanges.

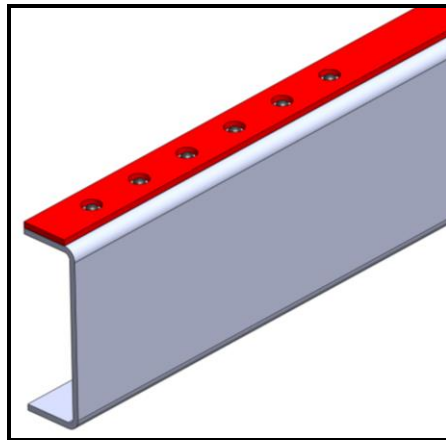
Figure 2: Preferred Packer Configuration (Sub-Frame not shown)

Ideally, full length packers should be installed prior to installing the subframe and body. One method of achieving this is to measure the locations of the rivets then cut holes in the packers so they can sit flush on the upper surface of the top chassis rail flange. This method prevents the packers from falling out as they are held in place by the rivets. Once the packers have been installed, the subframe can rest on the packers and the body can be installed in accordance with Section J of VSB-6.

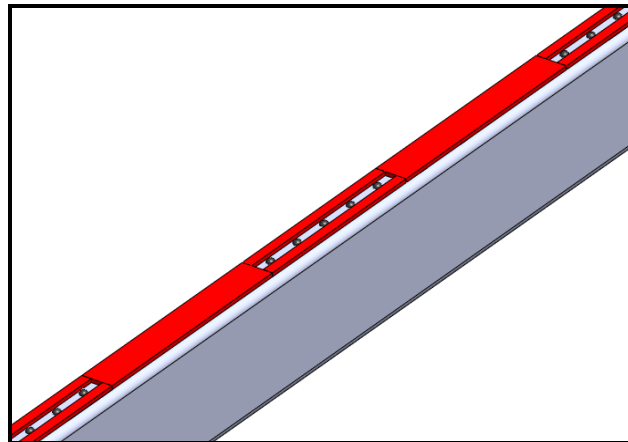
Figure 3: Possible Packer Configuration for pre-existing bodies (Sub-Frame not shown)

If the body has already been installed and the packers are not satisfactory, the problem can be rectified by installing full width packers in the regions where rivets/bolts are not present and installing narrower packers either side of the rivets, as shown in Figure 3 below:

If this method is used, the packers must be adequately secured so that they do not fall out. If metal packers are used, it may be acceptable to weld them to the sub-frame in a manner which doesn't affect the structural integrity of the chassis. Care should be taken to ensure the chassis is not subjected to high temperatures. Packers and/or any other brackets/equipment must never be welded to the chassis.

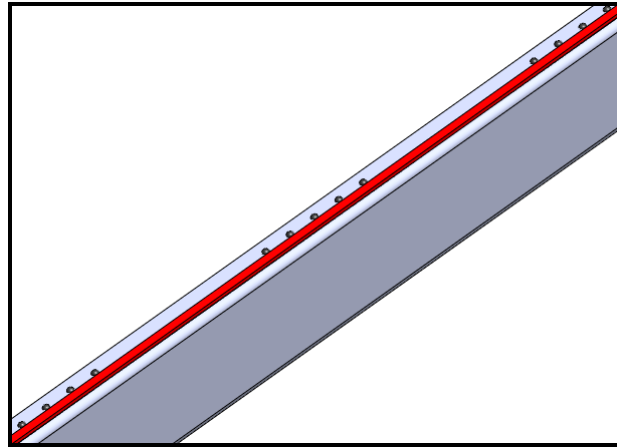
Figure 4: Alternative Packer Configuration to Figure 2

As long as the contact surface between the chassis and the packer is consistent along the length of the packer, this configuration is also acceptable.

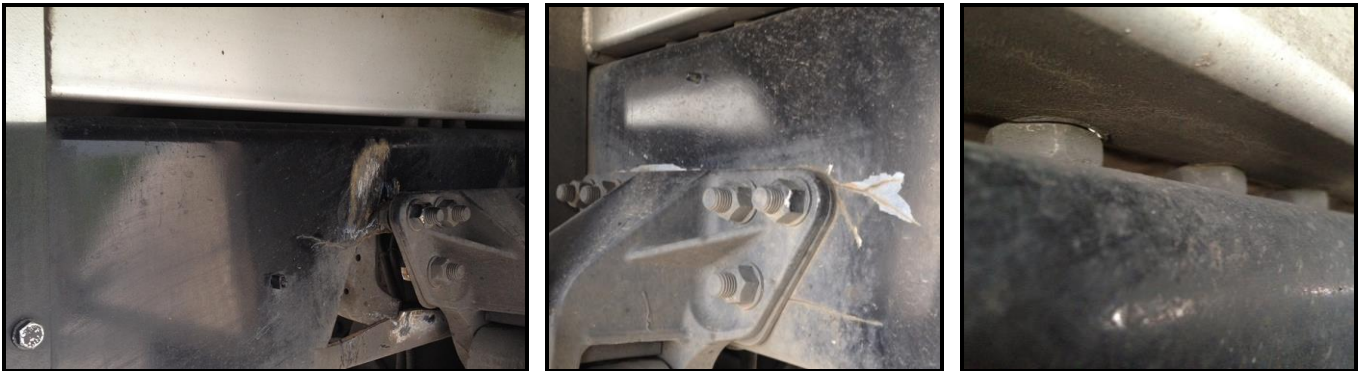
Figures 5a, 5b and 5c: Alternative Packer Configuration to Figure 2

It is evident from the figures 5a to 5c that excessive vertical chassis vibration has occurred in the region where continuous packers are not present, which contributed to the cracks around the suspension hanger bolts. Inserting a continuous packer between the chassis and the sub-frame would have greatly reduced this chassis vibration.
